BUREAU OF SHIPS  
TECHNICAL INSPECTION REPORT

BEACHED LANDING CRAFT  
TEST ABLE [U].8

⑥ OPERATION CROSSROADS

BEACHED LANDING CRAFT

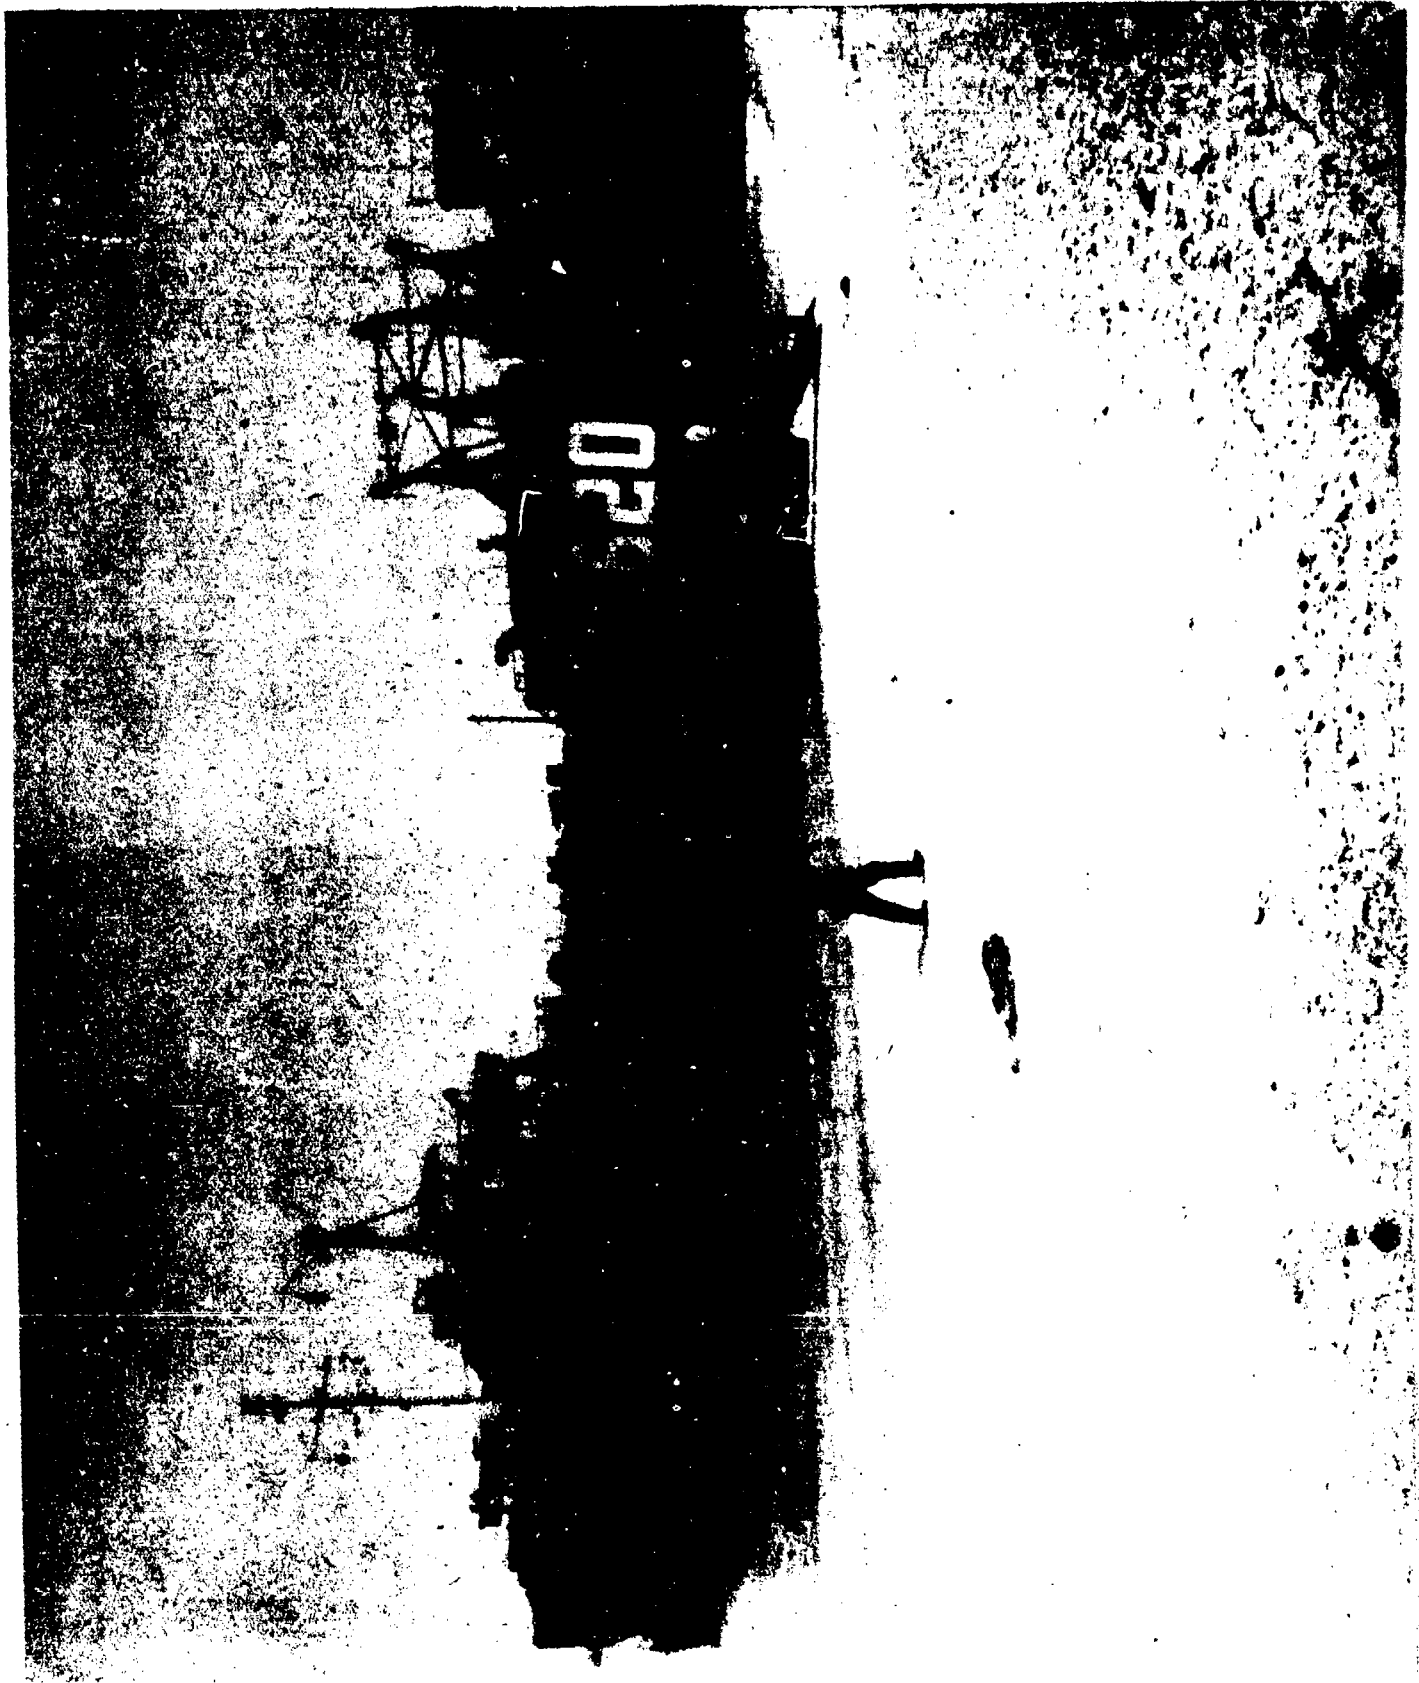
No damage. (Photograph 1956-7, page 14 ).

AA-CR-98-1956-7. LCI-620 after Test A.

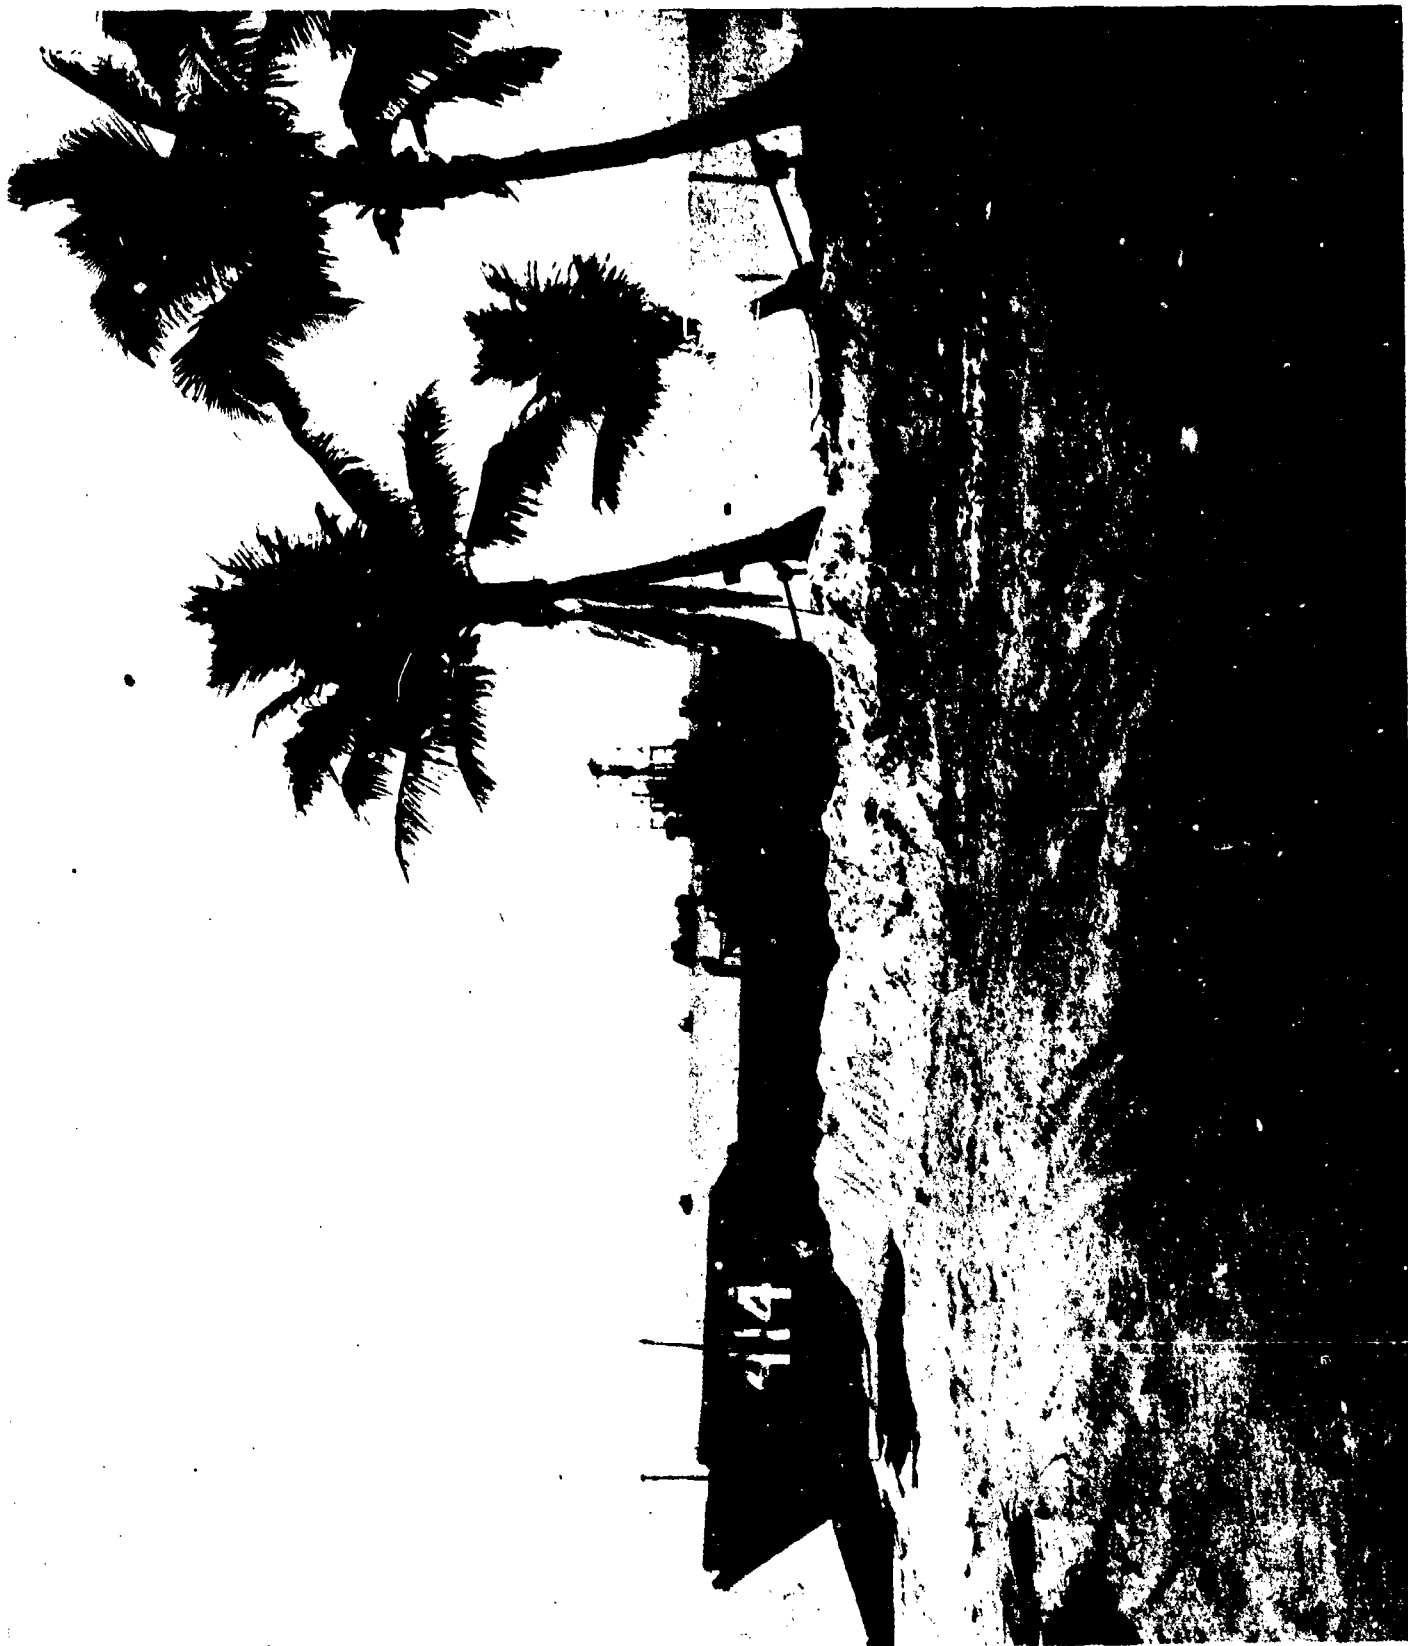
As a result of air blast, a canvas awning tore loose its pipe supports. The machinery space flooded completely through leaking stern tubes. This craft broached 90° from its original position. (Photograph 1957-1, page 15 ). When attempts were made to move the craft back to its original position, it was grounded solidly on a coral head.

AA-CR-98-1957-1. LCT-414 after Test A.

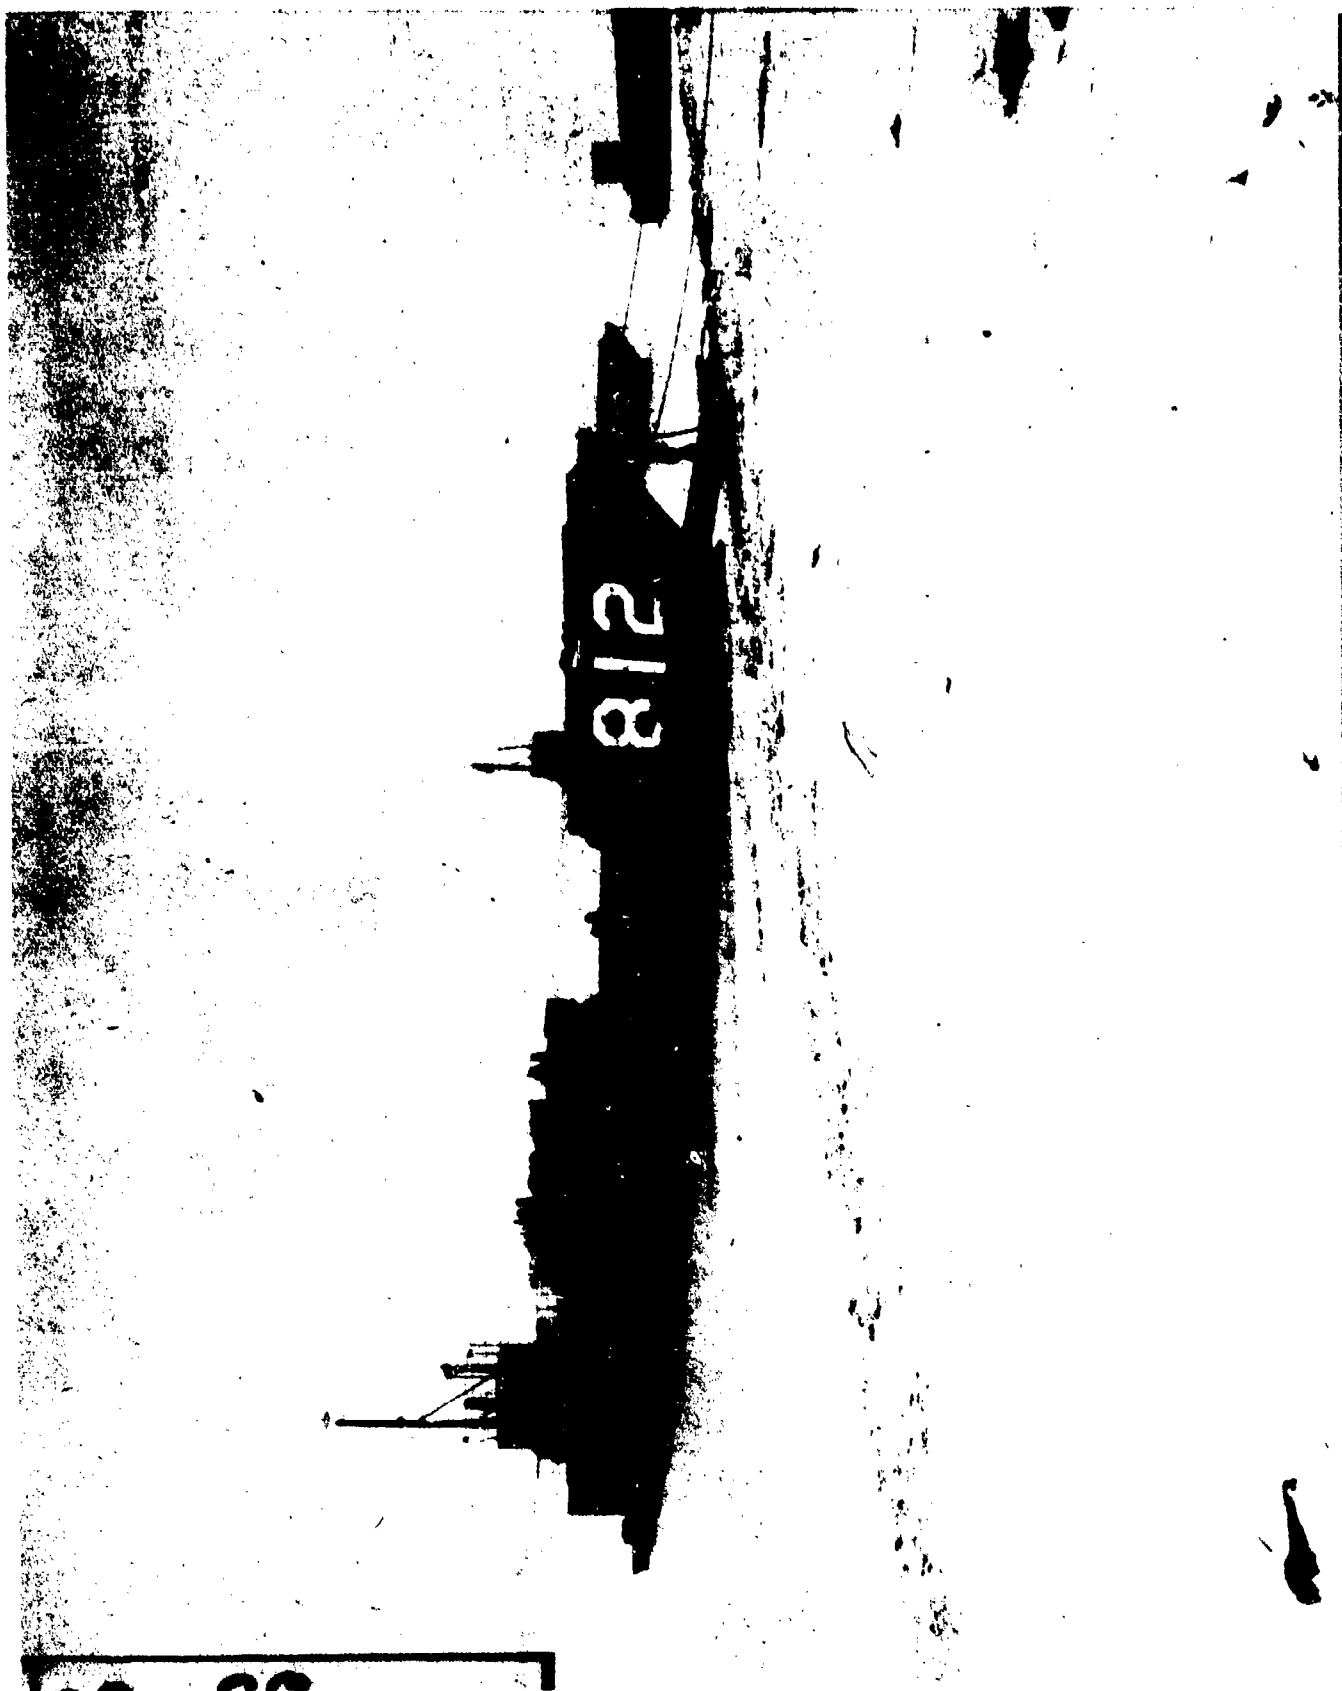
At the time of inspection, this craft was striking heavily forward on coral ledges. The engine room flooded to within 2 feet of the overhead from a 10 inch split in the bottom plating. The ramp was down on the beach, probably left in this position for the test. The damage is considered to be the result of wave action during the unattended period. (Photograph 1958-3, page 16 ).

AA-CR-98-1958-3. LCT-812 after Test A.

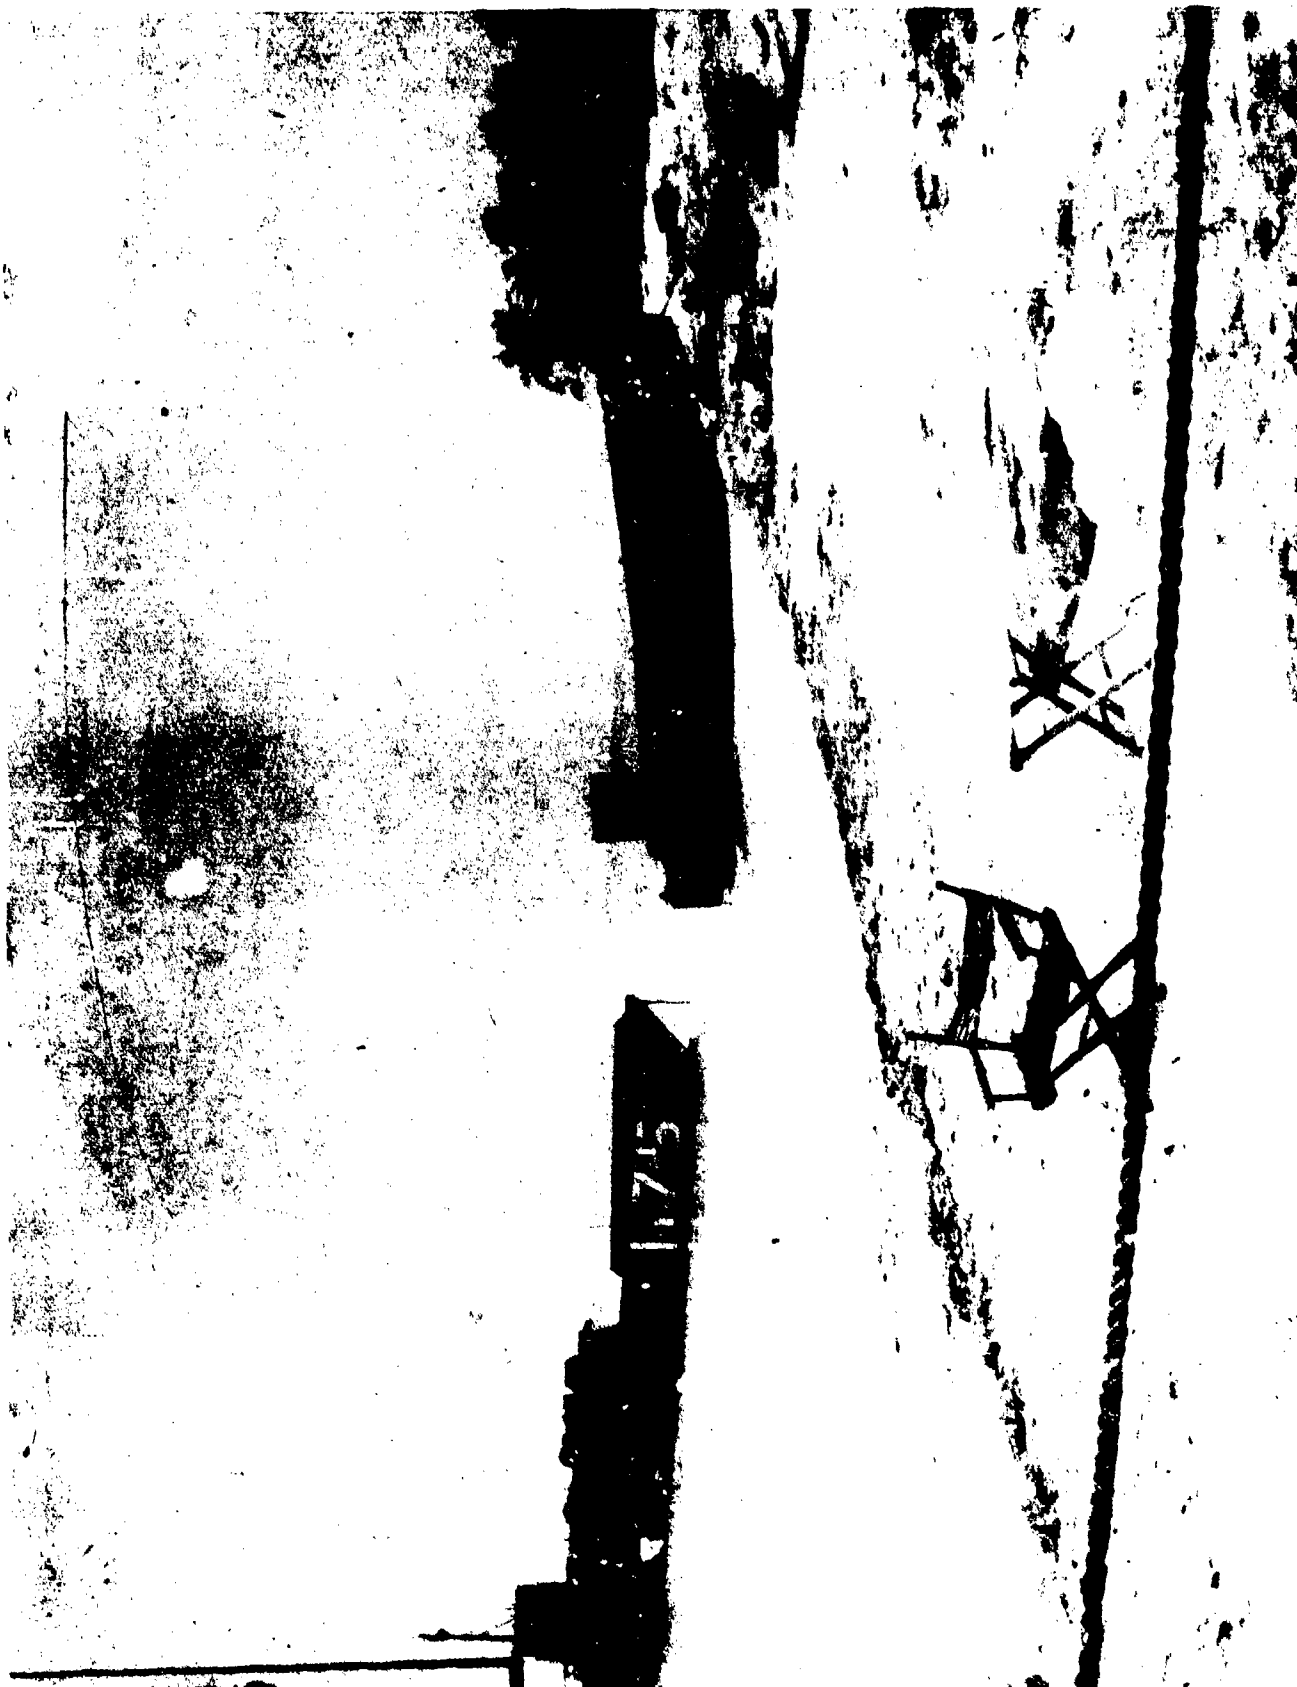
This craft was found down by the bow with the main deck awash forward and a slight starboard list. The engine spaces remained dry. Flooding forward apparently resulted from striking coral during the unattended period. (Photograph 1958-4, page 17 ).

AA-CR-98-1958-4. LCT-1175 and LCM-4 after Test A.

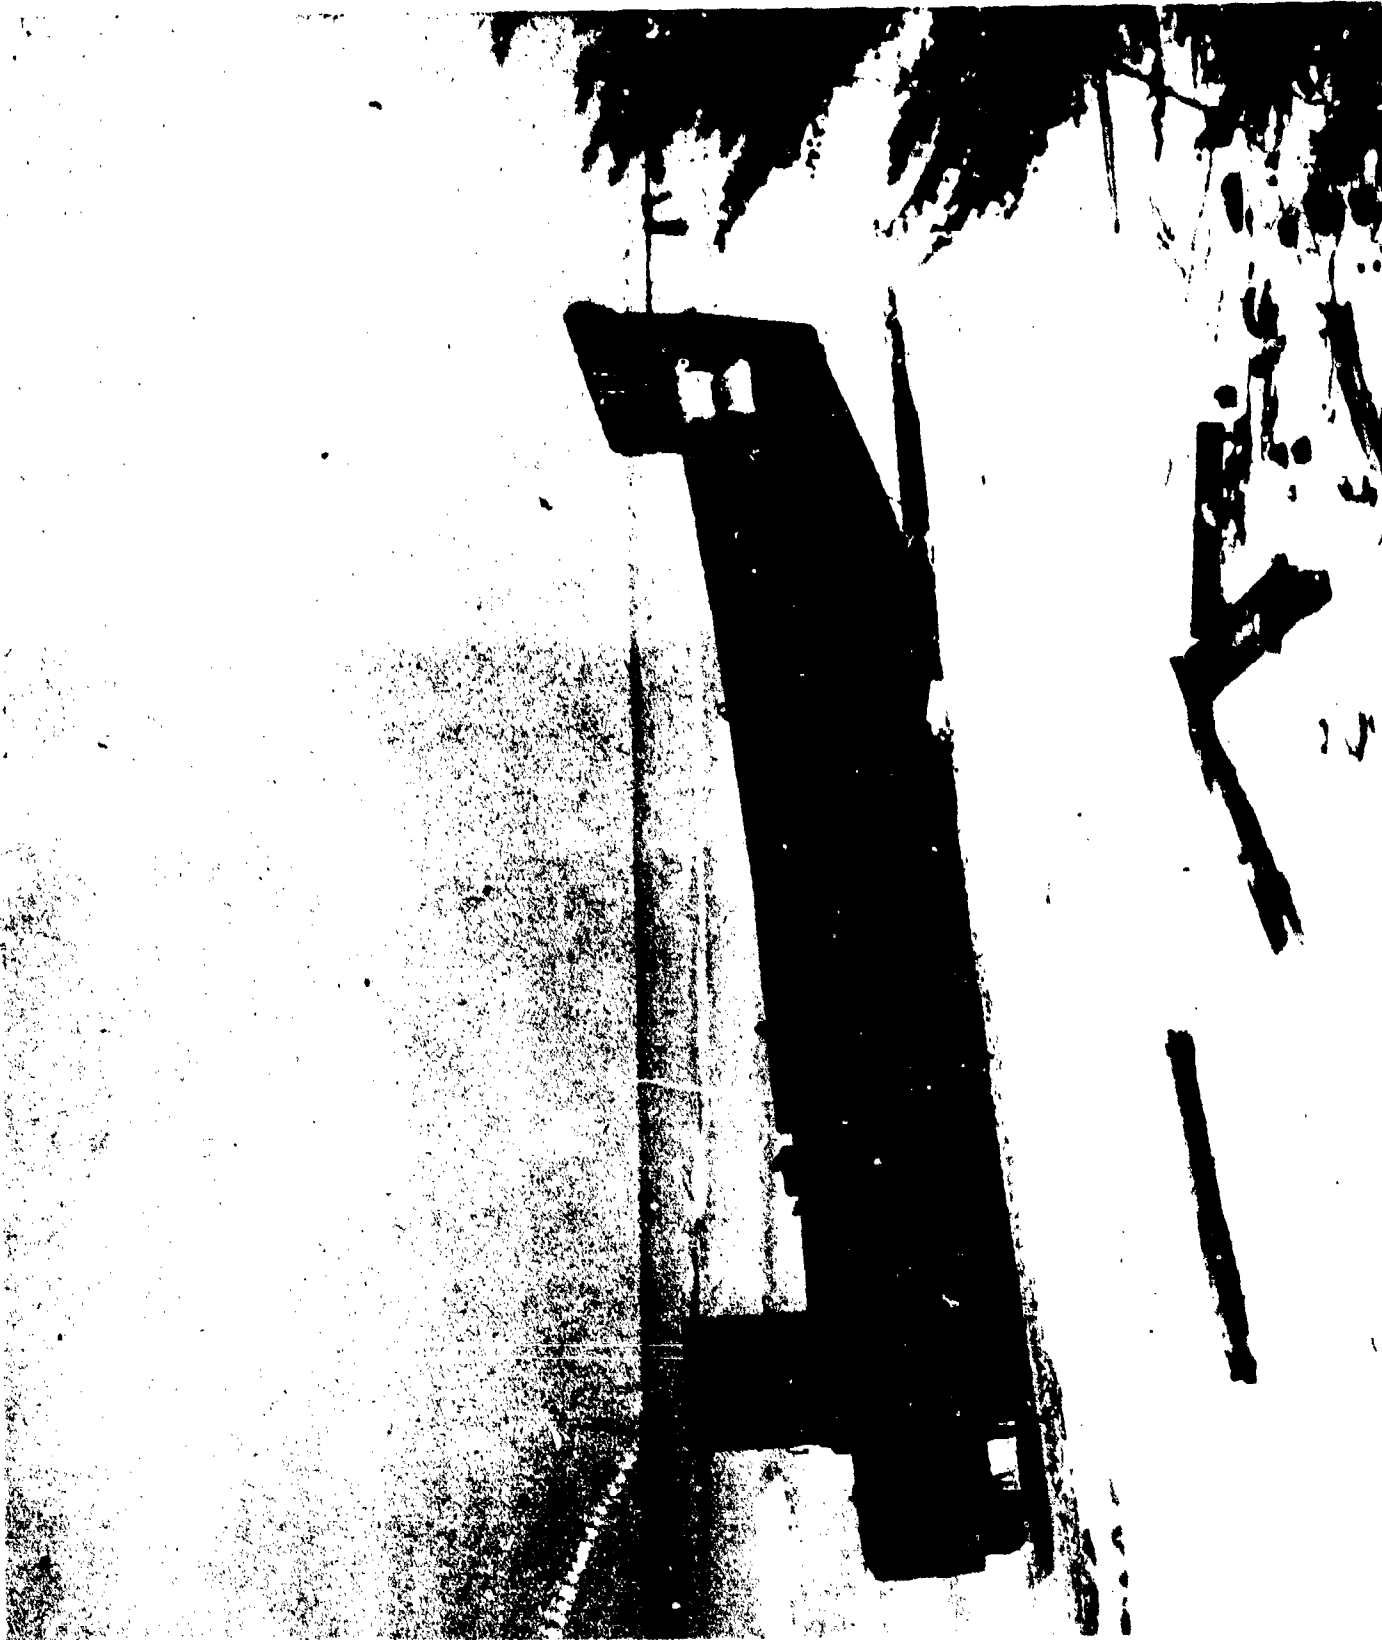
No damage. (Photograph 2822-1, page 19 ).

AA-CR-199-2822-1. LCM-2 after Test A.

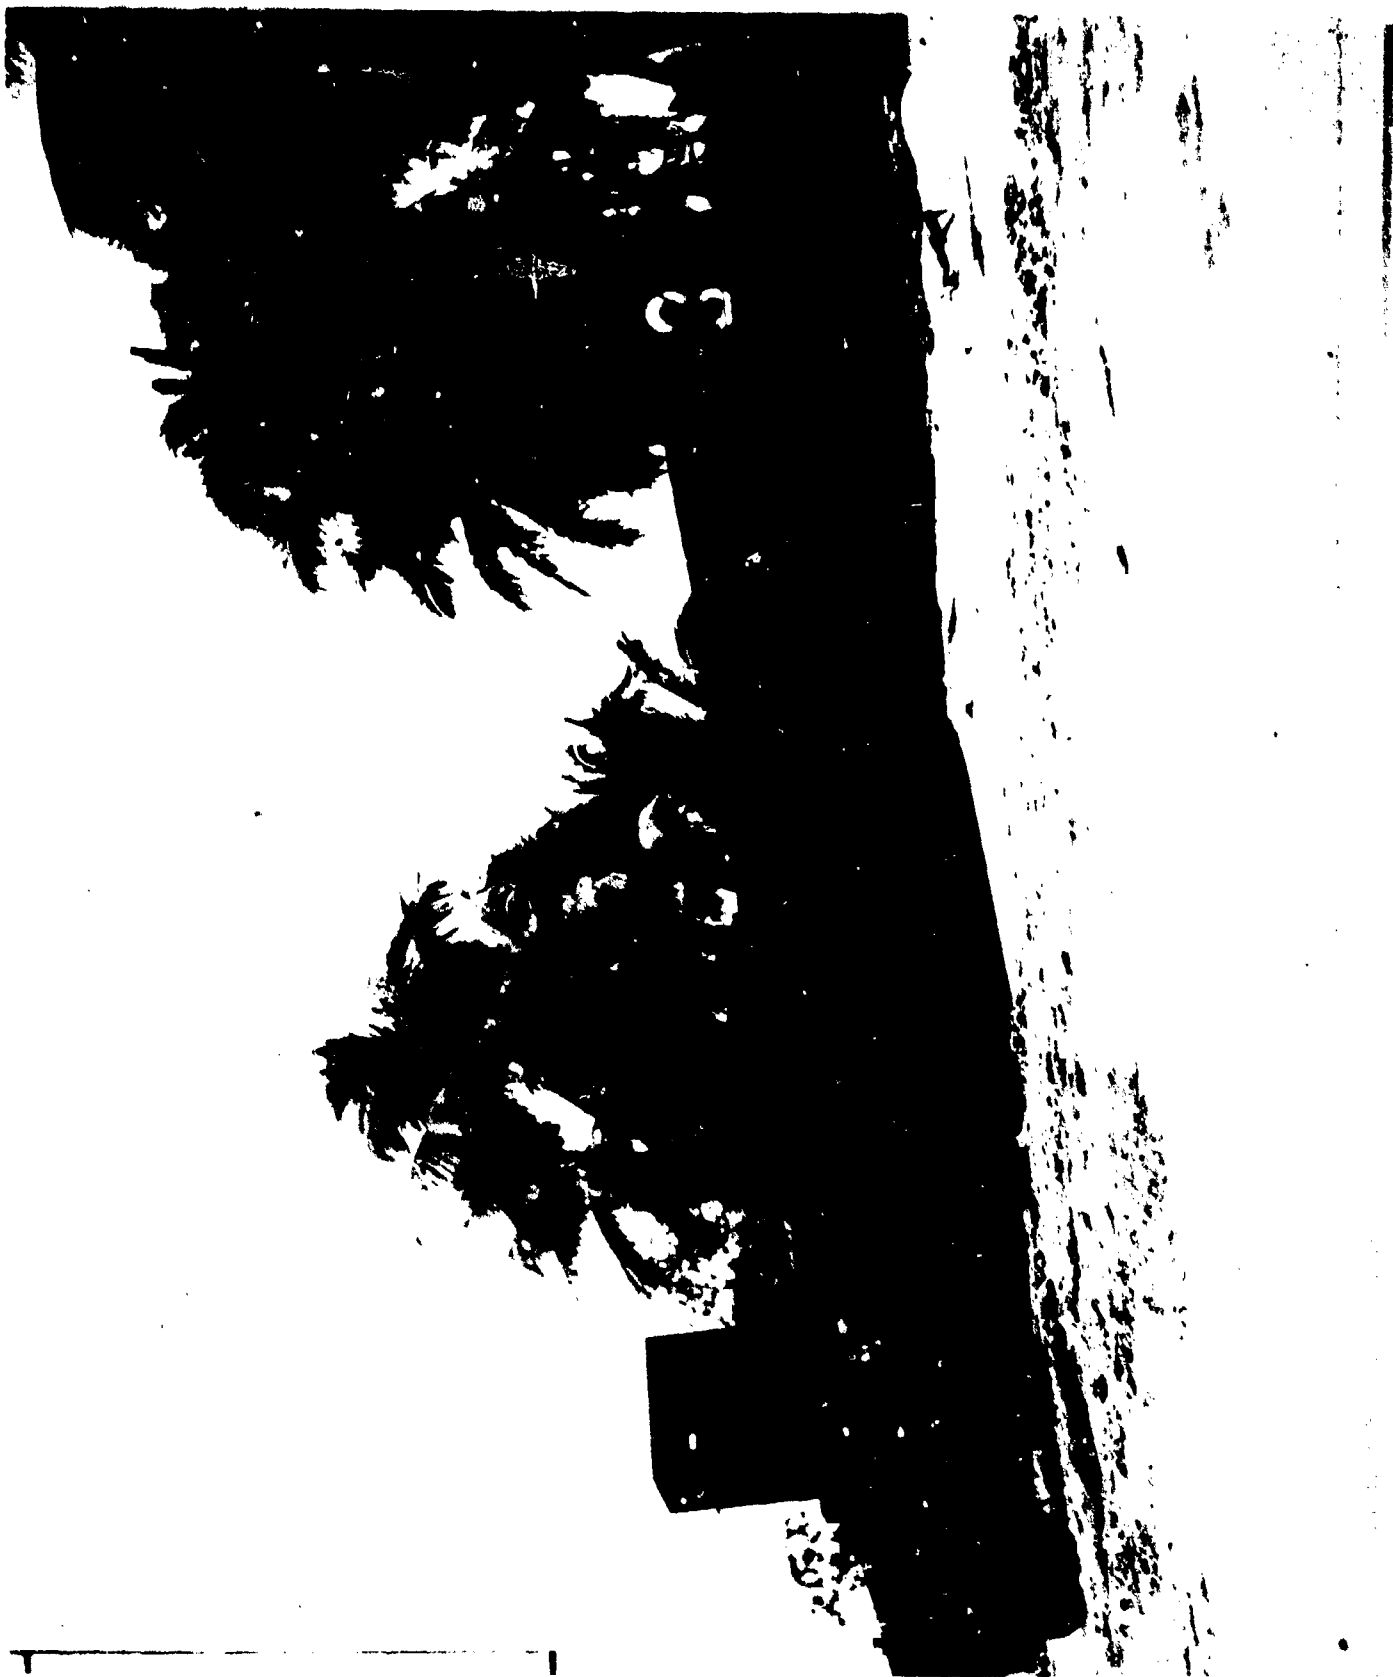
No damage. (Photograph 2820-8, page 20 ).

AA-CR-199-2820-8. LCM-3 after Test A.

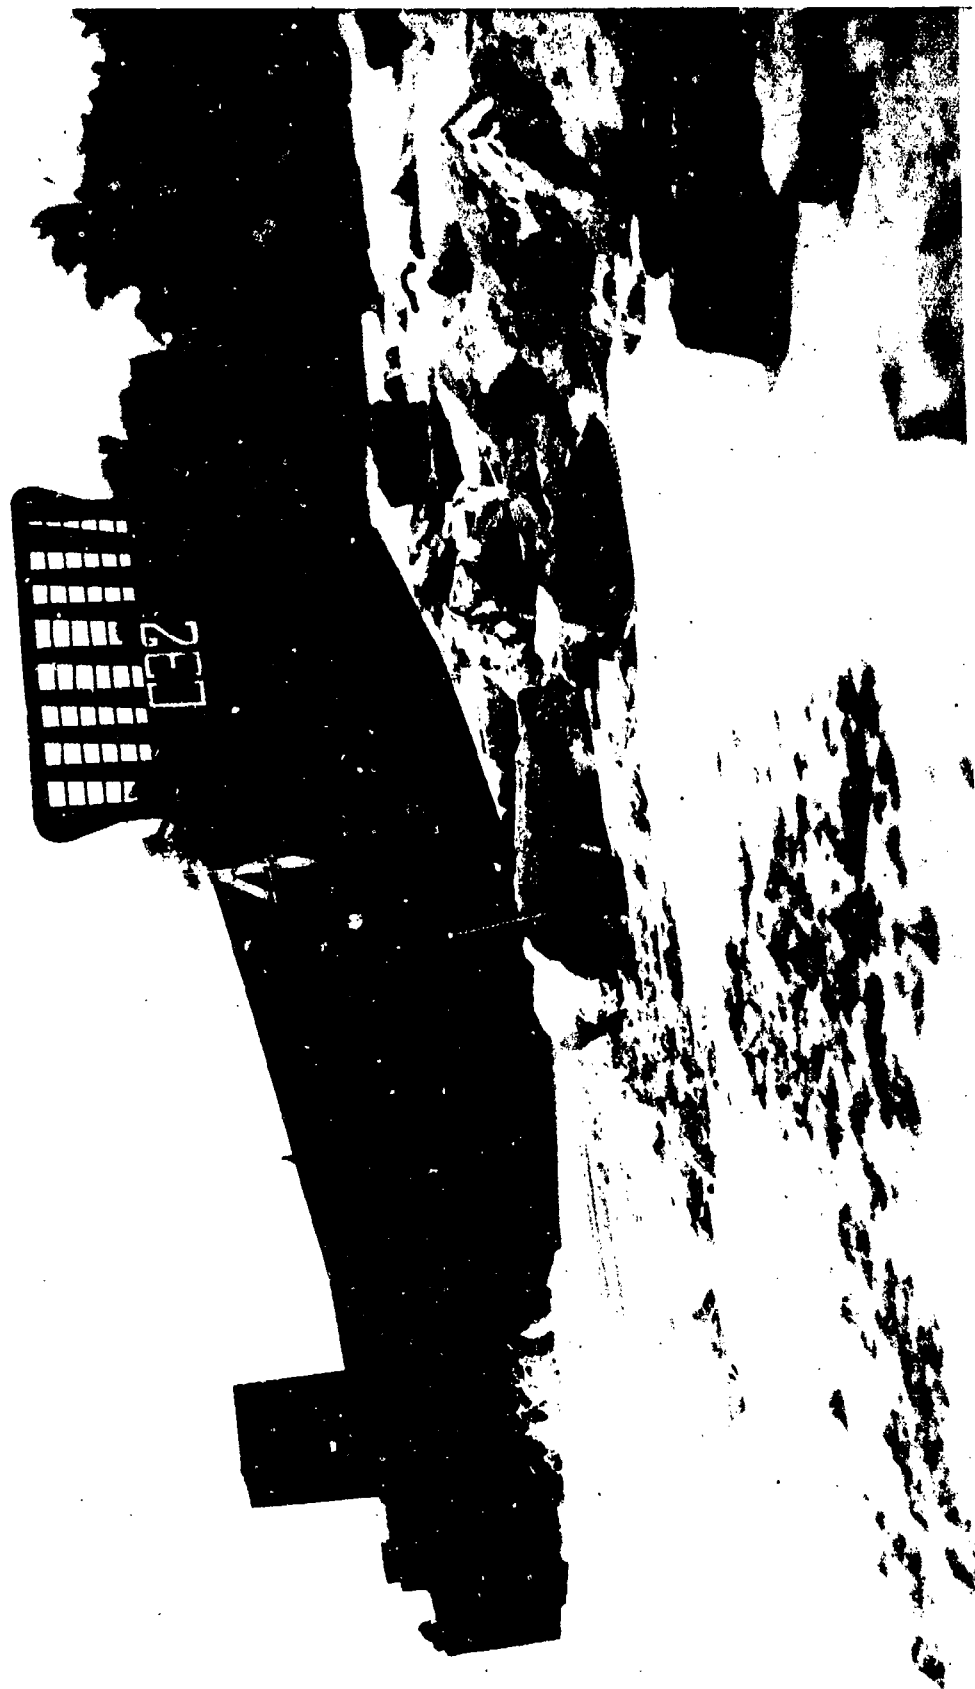
The engine room flooded over the motor stringers, probably from leaking shaft packing glands. Compartments astern of the engine room flooded to a depth of 16 inches. No other effects were noted. (Photograph 2819-8, page 21 ).

AA-CR-199-2819-8. LCM-4 after Test A.

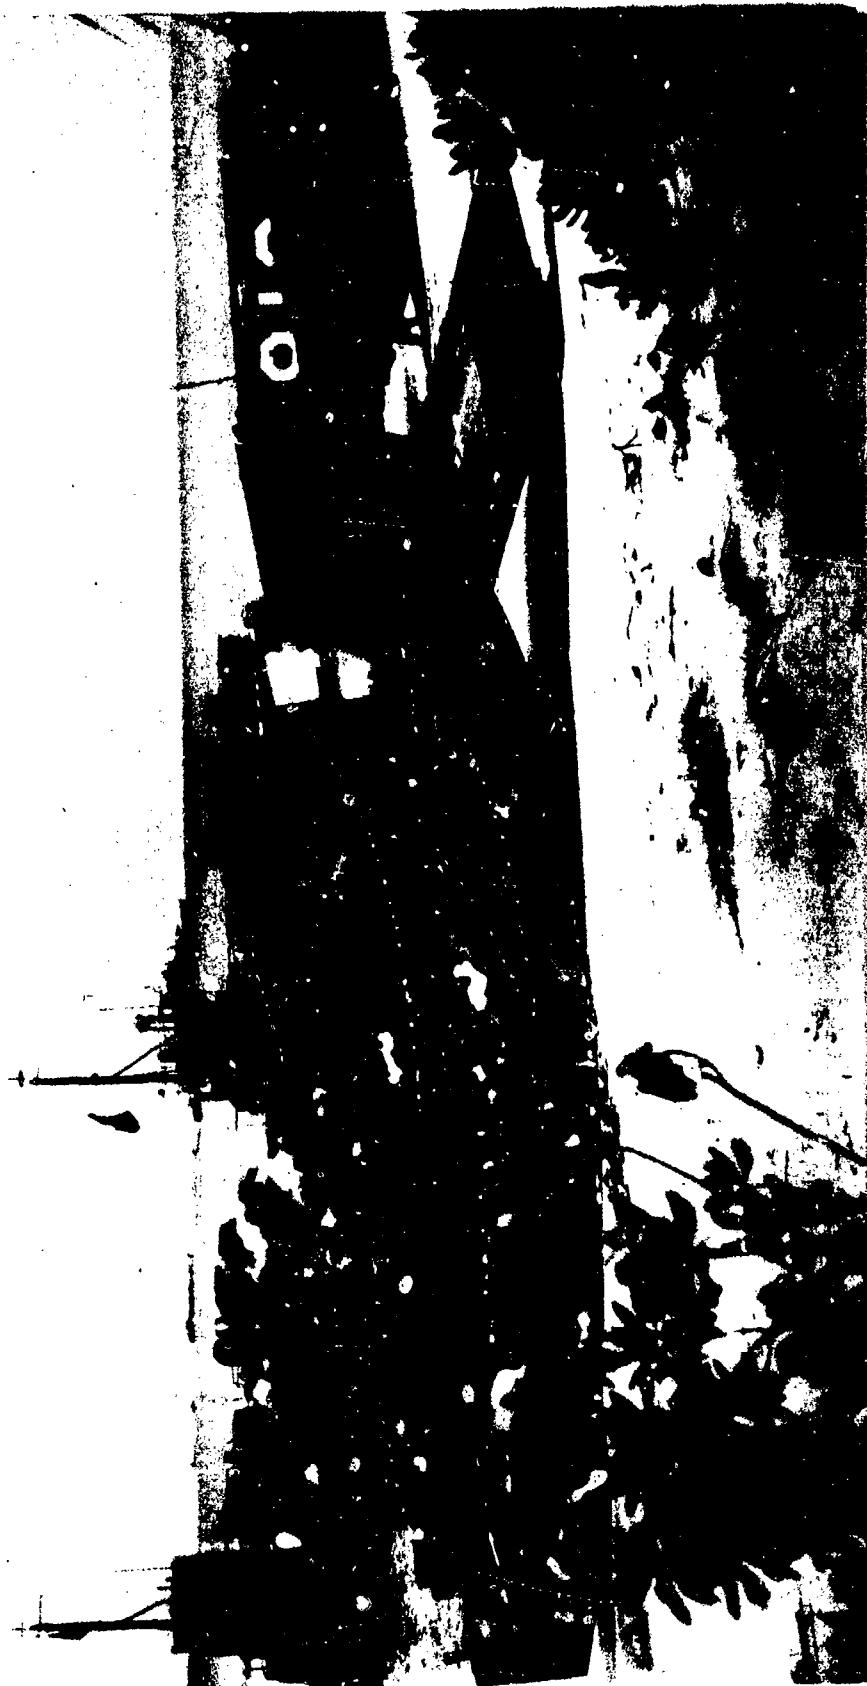
The ramp securing cables were parted and the ramp was down. It is questionable whether this occurred during the test. The support for the port cable bow sheave is bent and the welded attachment of this support is broken. This damage appears to have occurred prior to test A. (Photograph 2818-2, page 22 ).

AA-CR-199-2818-2. LCM-5 after Test A.
